# Slate Quarrying in and around Maenclochog

## The Rosebush quarries

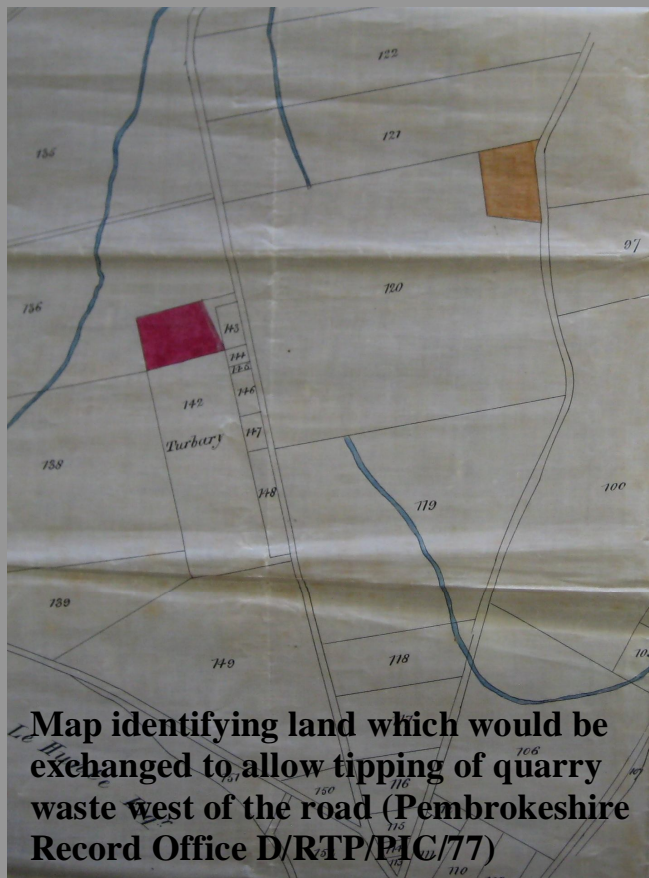
There is also evidence to suggest that water power was used much earlier. A leat (watercourse) enters the Bellstone / Precelly Quarry from the north and another can be identified to the south of the Rosebush Quarry – see the map below, dated 1869

Both leats can still be traced although close to the quarries they are lost under the spoil heaps. What is unclear is whether the southern leat was taking water to the quarries or taking the tail water away to be used elsewhere – the map of 1869 indicates the water running down slope, away from the quarry, to the east of Mount Pleasant. This requires further investigation and is typical of the questions which remain unanswered for many of the slate quarries in north Pembrokeshire. The quarries are significant features in the landscape but much of their history and archaeology remains a mystery.
